KEYSTONE STATION DAM

Ohio River Basin, Plum Creek, Armstrong
County, Pennsylvania.

PHASE I REPORT
National Dam Inspection Program

15 May 1978

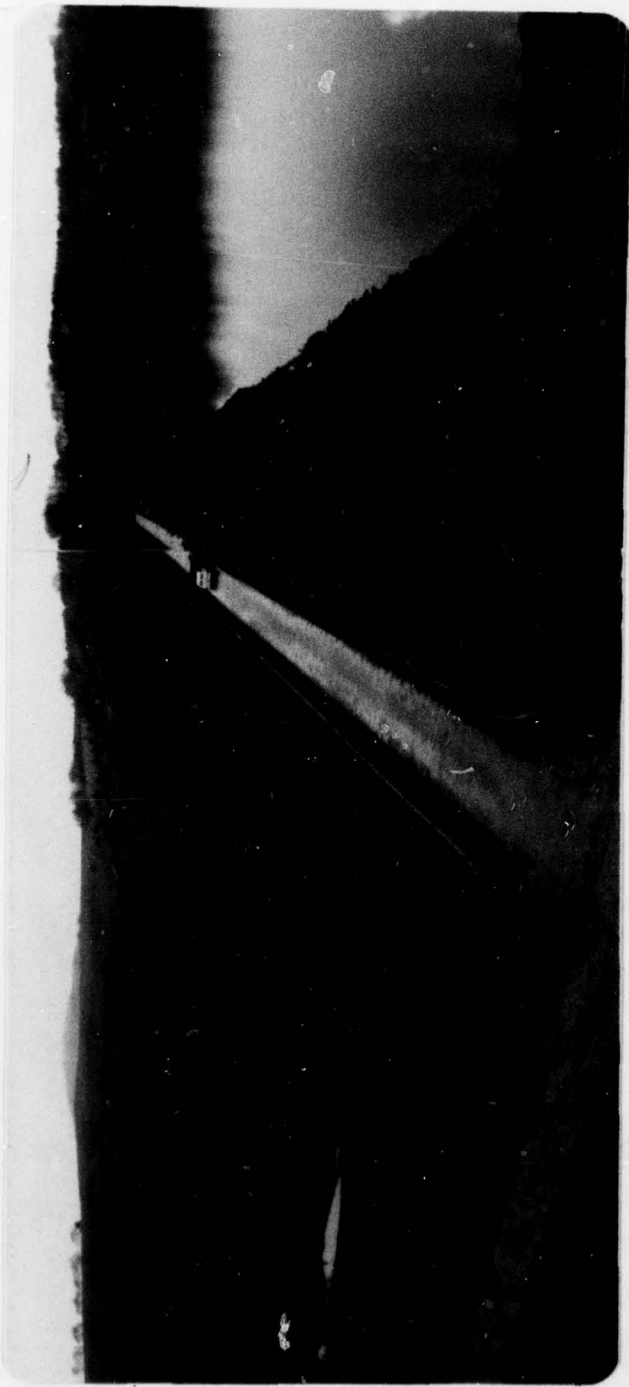
PHOTOGRAPH 1 Panoramic view of the Keystone Station Dam, the area immediately downstream, and the reservoir area. Note the wide open valley just downstream of the embankment.

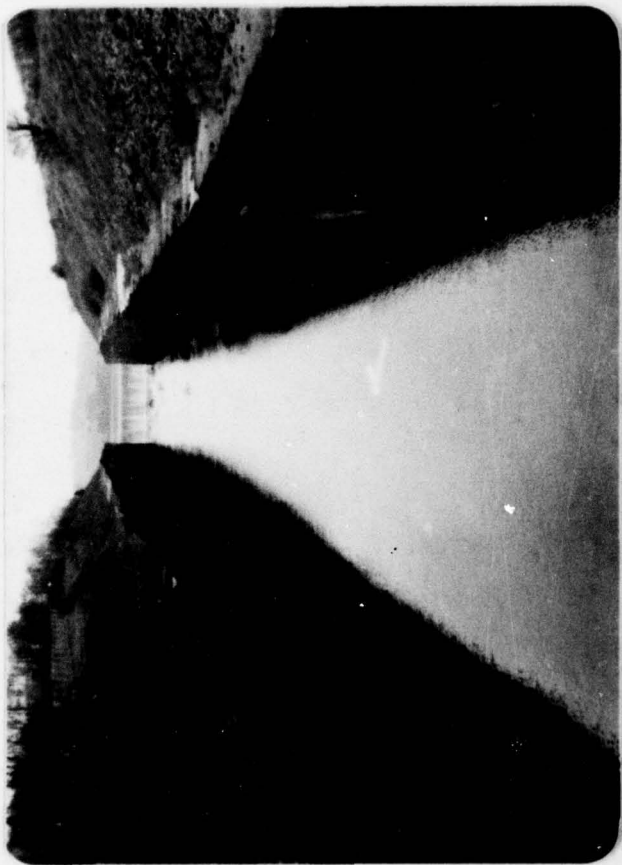
PHOTOGRAPH 8 This is a view of the spillway at the Keystone Station Reservoir located approximately one mile upstream of the Keystone Reservoir embankment.

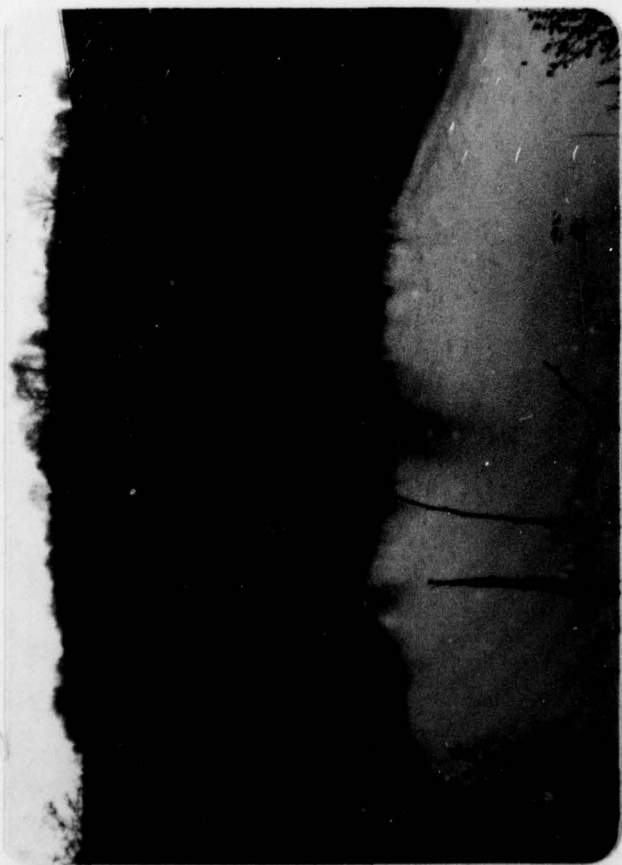
PHOTOGRAPH 7 View of the toe drain of the embankment and the relief wells mentioned in the previous photograph. The weir in the center of the photograph gauges flow from the area of the right abutment and any flow which might be discharging through the relief wells.

a. The minor sloughing and seepage on the right abutment near the elevation of the berm and the fact that a piezometer was discharging while the relief wells were not should be noted by the Penelec consultant on future inspections.

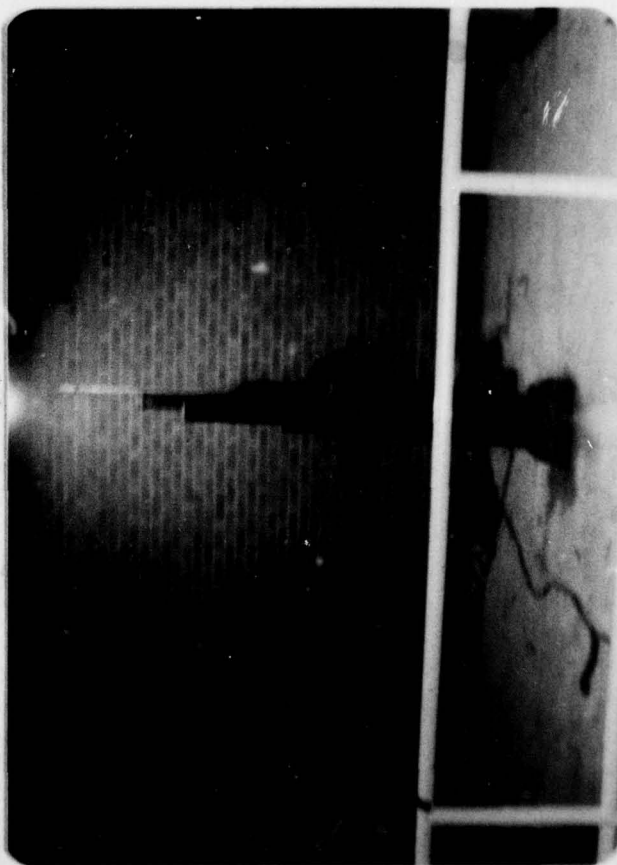
PHOTOGRAPH 9 This is a view of the interior of the gate house at the Keystone Reservoir. The gate controls in the center of the photograph are used to raise sluice gates on the discharge system for the reservoir.
